# Where is that vibration coming from?

## » Production plant analyzes resonance anomaly; looks at condition monitoring program as a profit center

By Roger Earley, Lubrizol Corp., and Mike Fitch, Ludeca Inc.

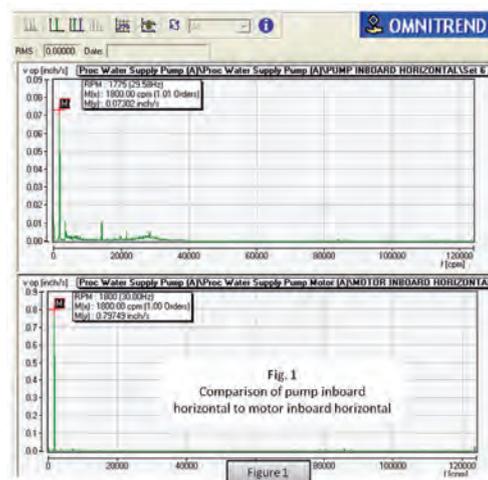
It can be seen in Figure 1 that the horizontal peak at turning speed on the pump, while easily the dominant peak in the spectrum, is much lower than the horizontal turning speed peak on the motor (amplitude scale is 10x higher on the motor). Shaft

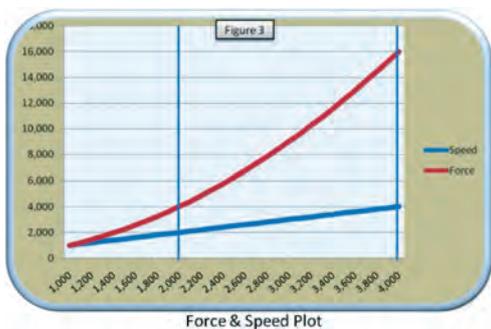
yield 1,000 lbs of force at 1,000 rpm, so they begin at the same place on the chart. The horizontal (X) axis is speed and the vertical (Y) axis is force.

Notice that as the blue line representing speed doubles from 1,000 rpm to 2,000 rpm, the red line representing force has now reached 4,000, having quadrupled because of the speed doubling. It is important to understand this, because the response vibration of a machine might be expected to increase like the blue speed line as speed is increased, but in fact, the response vibration in a machine should follow the slope of the red force line. Following the slope of the red force line looks dangerous enough as speed is increased on a machine, but when you add a resonance, the slope of the response vibration amplitude can go nearly vertical. We will use a variation of this chart a little later to help visually illustrate the amplification of vibration on our pump motor.

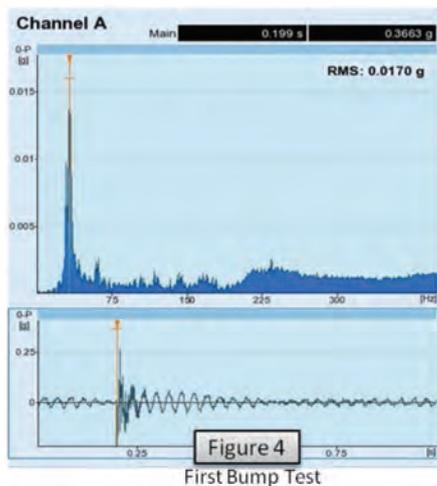
instrument in the field “seeming” to confirm a resonance very near to motor rated speed.

Notice the waveform of the bump test. Not only did it not ring down to zero, it did not start at zero. The energy from the other pumps migrated into the accelerometer contaminating the bump test. Although contaminated, the test still yields interesting information, especially in the waveform.

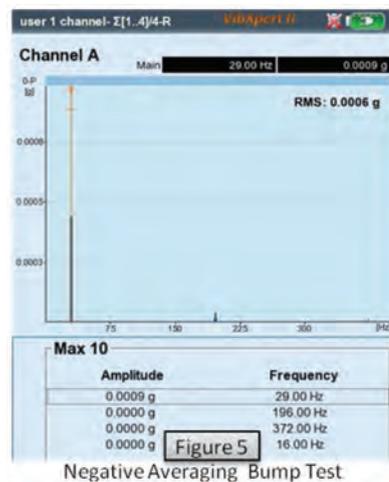
The migrating vibration before the bump appears to be dominated by virtually the same frequency as dominates immediately after the bump.

running. The result (Figure 5) confirmed the resonance in the horizontal on the motor at 1740 cpm.

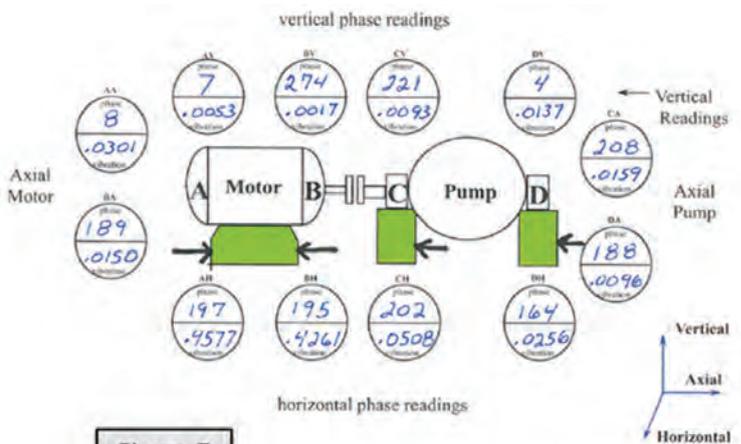
Figure 7 is the first bubble chart. It can be seen that the entire motor was vibrating from end to end “in phase.” The “bubbles” in the chart show the relative phase on top, and the amplitude in inches per second (ips) on bottom. The motor outboard horizontal amplitude and phase of 0.4577 ips at 1970 is comparable

to the inboard amplitude and phase of 0.4261 ips at 1950. This illustrates how directional the problem was. There is simply nothing of significance that is not in the horizontal direction and on the motor. After this chart was made, it was decided that to save time, data would be taken only in the horizontal direction. Other data could be taken in the future if necessary.

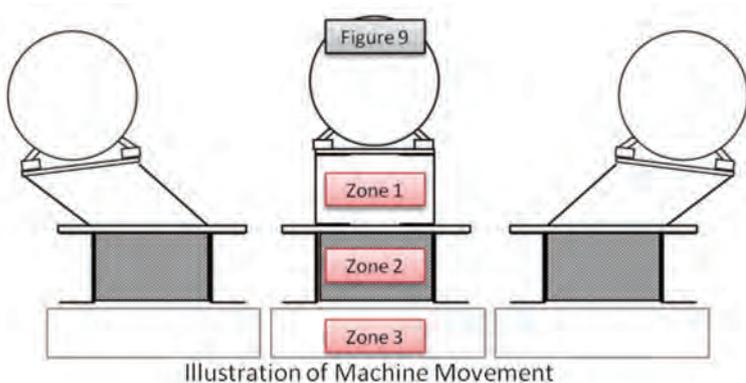
Figure 9 clearly shows how the motor mount and motor were rocking at the interface of Zones 1 and 2. This shows how the machine was vibrating due to a horizontal resonance, but the question why it was vibrating in this manner after years of operation without this behavior still remained.

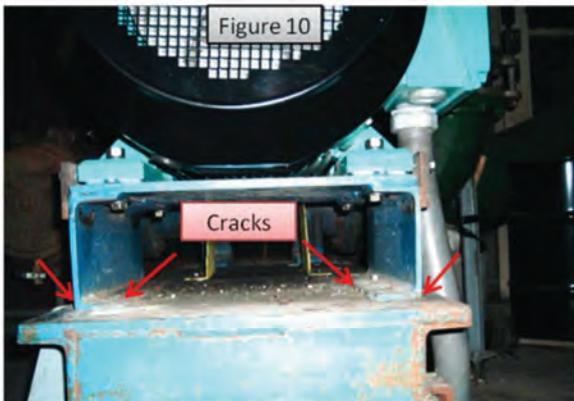
Cracked Welds Where the Mount attaches to the Skid

Figure 10 shows another view of the motor on its mounting. It was decided that the mount needed some internal bracing. While inspecting to determine the best placement of the gussets, cracks were found on the welds that connect the channels of Zone 1 to the top of Zone 2, which were hardly visible to the naked eye (see Figure 10). In fact, only extremely close scrutiny revealed most of

them. It was believed that the violent catastrophic failure that occurred earlier caused some welds to crack, lowering the stiffness of the motor/mount

assembly and bringing its natural frequency down near to operating speed. When the new motor was installed, it was doomed also, if the situation wasn't remedied.

The welds were repaired and gussets were made and installed to beef up the mount. Figure 11 shows the mount after the final repairs and Figure 12 shows the bubble chart made after the repairs and enhancements to the mount.
