TipTop Electrical Power Facility
2222 Ampstead Prkwy
Hot Springs, AK 91918

Vibration Survey for
Boiler Feedwater Pump Train 1A

Submitted on
January 1st 2014

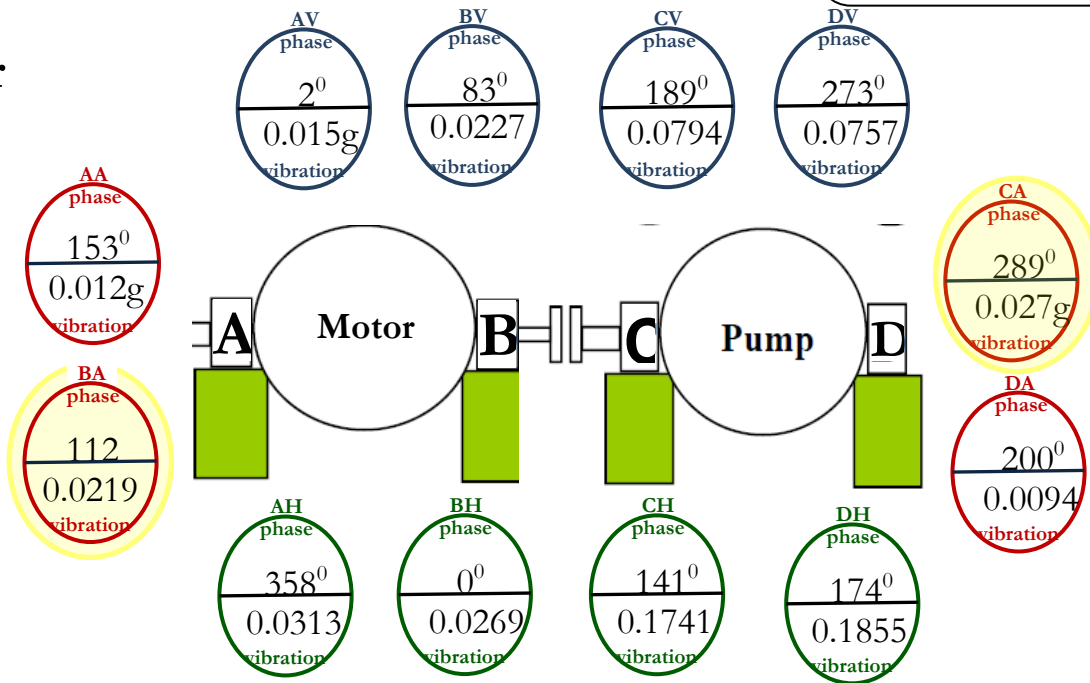
Fig 1

The phase analysis reveals that the axial readings across the coupling are 180° out of phase. It should also be noted that while each machine is relatively in phase end to end, they are out of phase to one another. These facts indicate some misalignment, but the amplitudes are relatively low. (see Fig 1)

The motor/pump combination exhibits some misalignment as revealed in the phase study. The amplitudes of vibration are not high enough for Ludeca to feel comfortable recommending the expense of shutting down the equipment to align it however; since the pump is presently shut down and there is a reasonably good possibility that the coupling is the source of the random high frequency axial vibration seen at the inboard of the motor, we do recommend that this coupling be thoroughly inspected and if the opportunity presents itself an alignment check would be prudent.

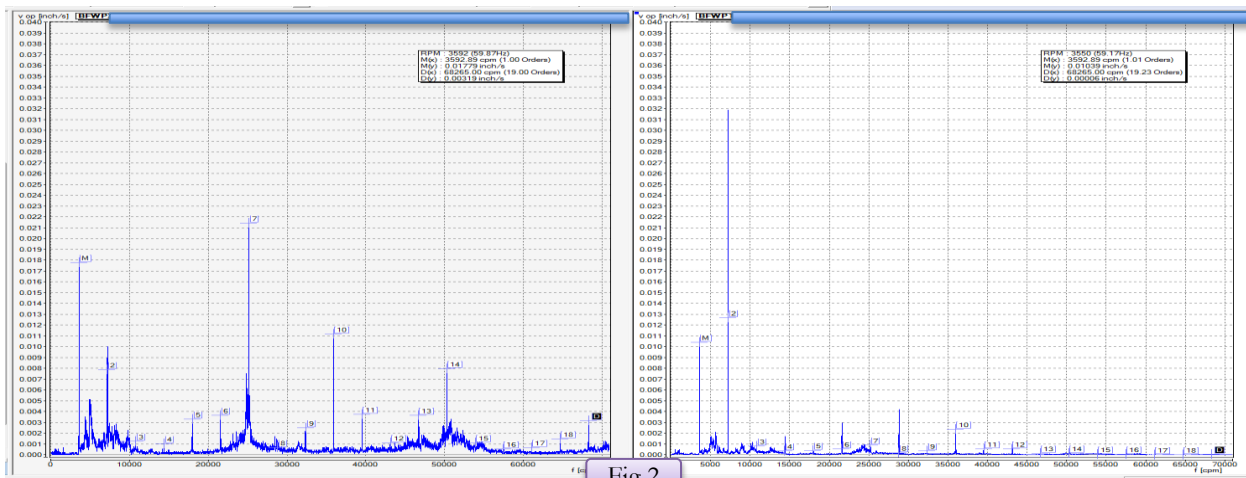
Fig 2

Figure 2 is a side by side comparison of the inboard axial frequency spectrums of 1A on the left and 2A on the right. There is a raised noise floor throughout the spectrum of 1A axial. This indicates random broad band activity and even extends into the higher frequency ranges. The extent of the high frequency excitation is clearly portrayed when the acceleration time waveform of 1A on the left is compared to 2A on the right with the same scale (Fig 3). We cannot say with certainty what the cause of this high frequency content is, but the coupling should be thoroughly checked including its lubrication (if applicable).

1. Inspect coupling thoroughly, assuring proper lubrication.
2. Collect vertical phase data at the motor inboard vertical to rule out machine looseness.
3. Check clearances of the inboard bearing.
4. Check lube system. If regular oil analysis is not performed, have a representative sample analyzed.
5. Trend this condition (looseness) for early warning of a progressing defect.

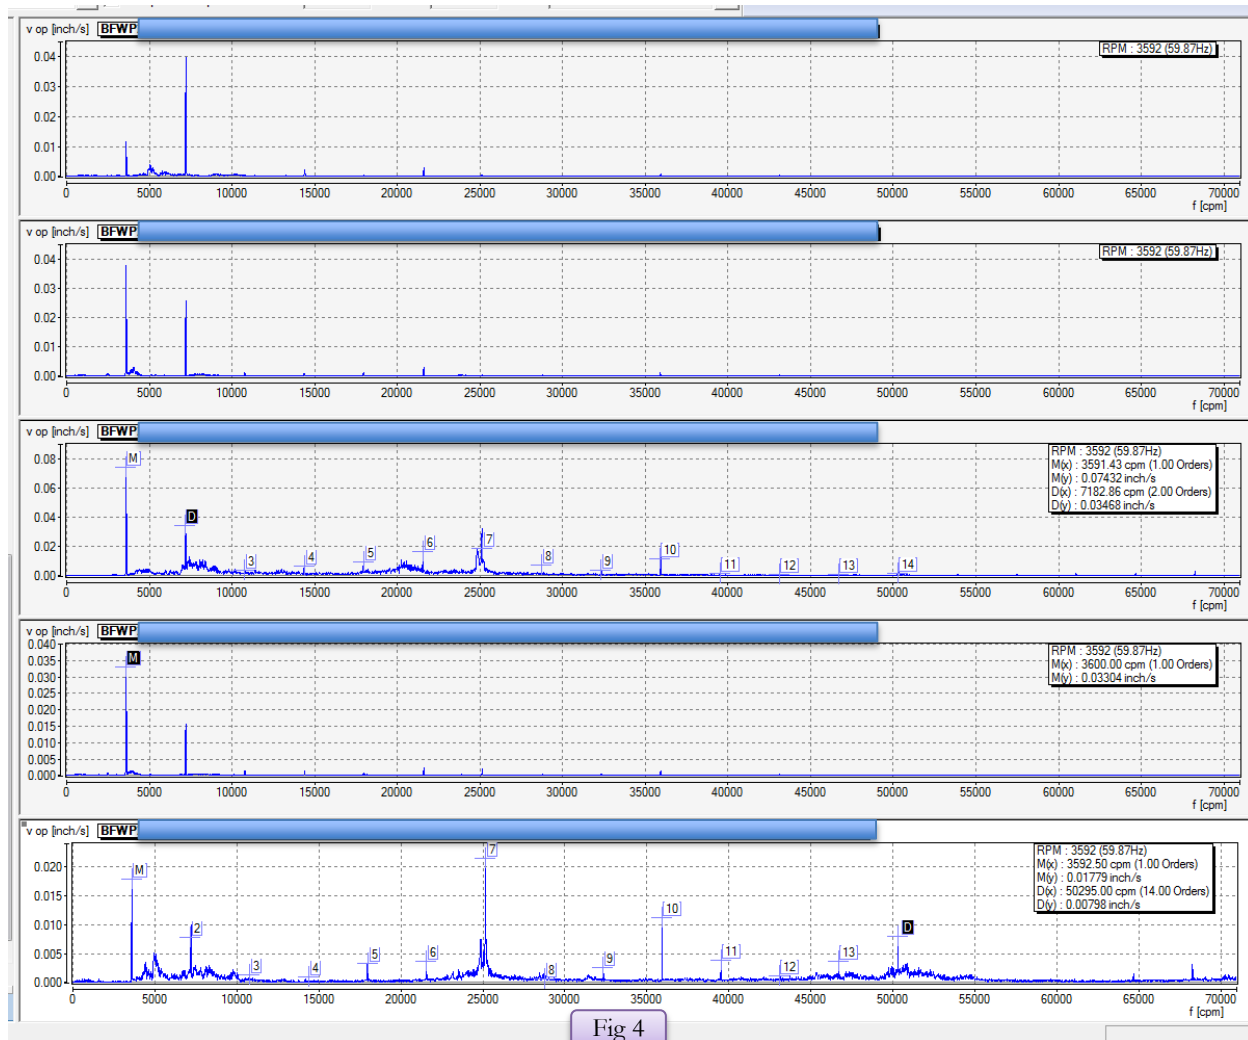
Fig 4

The radial spectrums of this motor (the top four spectrums below in Fig 4) all show relatively low amplitudes of vibration, with the 1x and 2x peaks dominating (supporting the misalignment shown in the phase study). The inboard vertical (#3 down from the top) shows a raised noise floor from about the turning speed peak to pump vane pass (7x). This is most likely carried over from the pump.

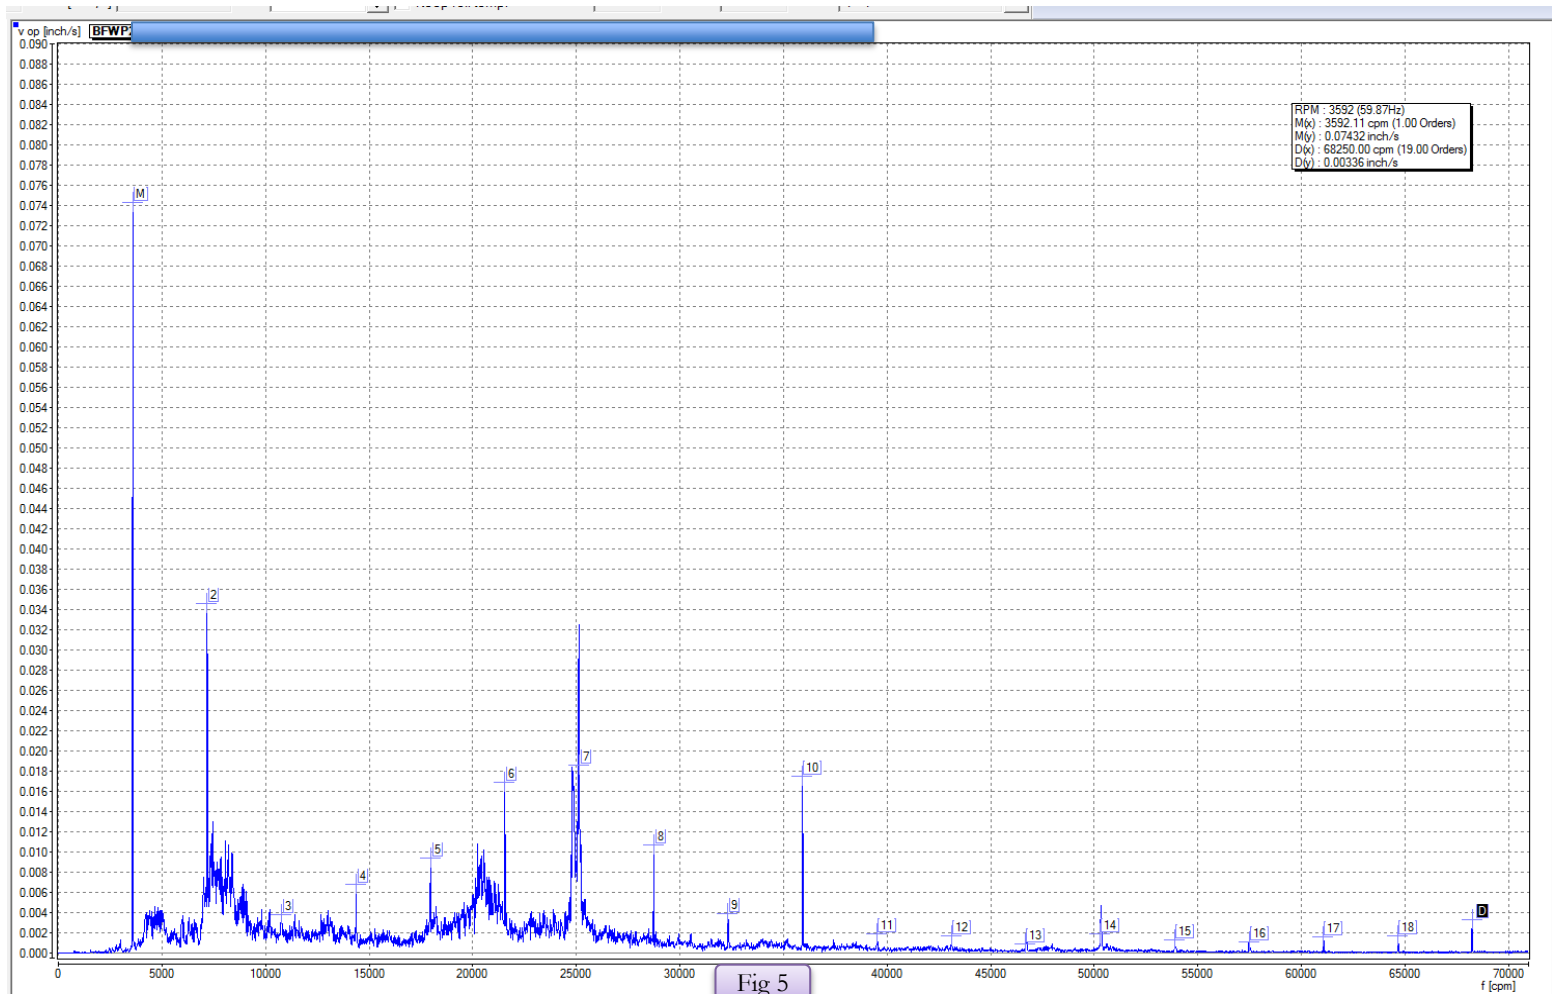
Fig 5

The IBV on the motor shows numerous multiples of turning speed which most likely indicates bearing clearance or misalignment (Fig 5), but vertical phase data from the foundation up should be collected in the future to rule out machine looseness. This can be accomplished during routine periodic route data collection.

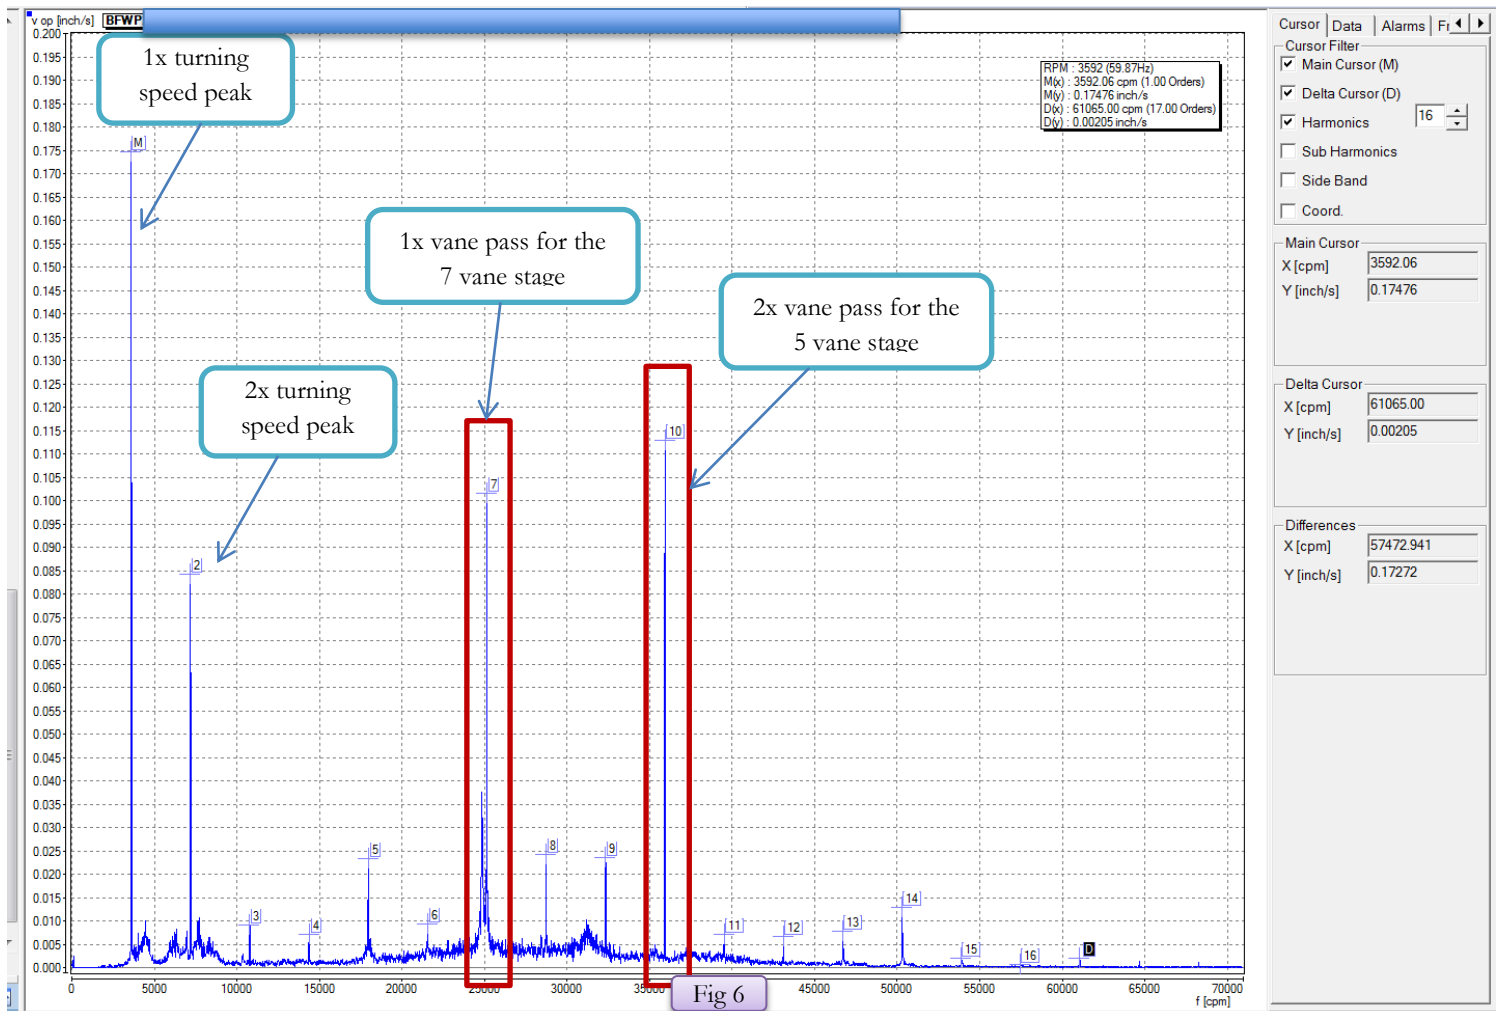
The DE horizontal pump casing measurement is showing an area of raised noise floor (Fig 6) and mounding from about the 1x turning speed peak out to the 2nd harmonic of vane pass. This could indicate some suction cavitation. The 1x and 2x turning speed peaks are prominent indicating some residual misalignment and or unbalance. Prominent vane pass harmonics should be trended to determine if they indicate a developing fault condition.

1. Check the suction screen, piping and valves to insure there is no restriction on the suction.

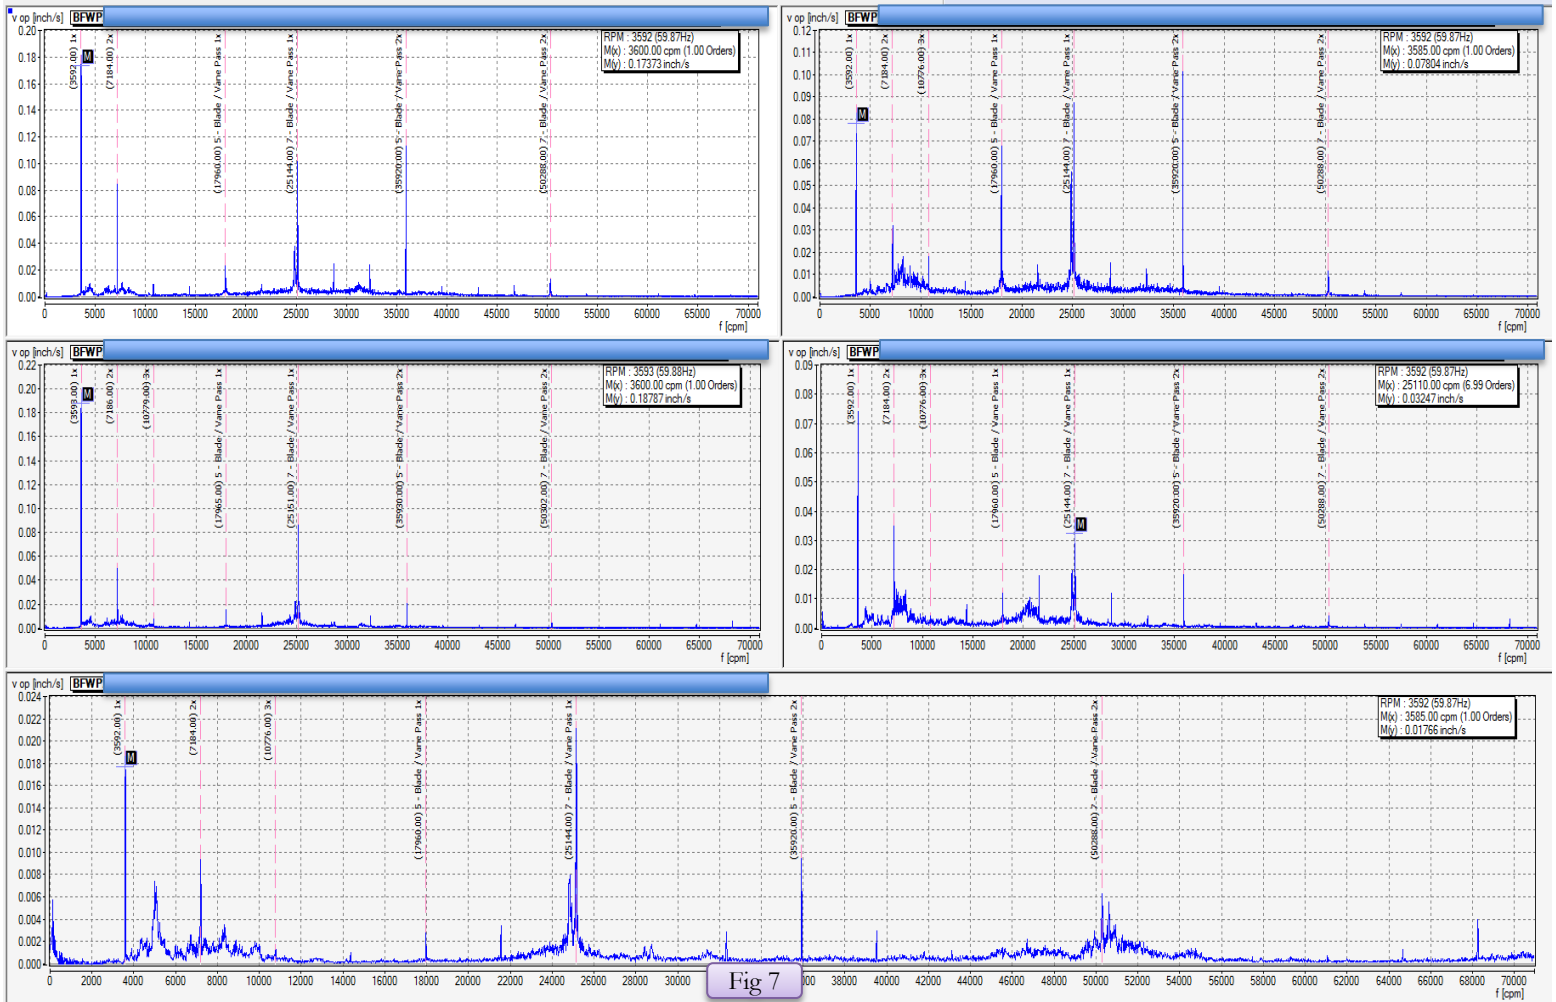
Fig 7

The pump spectrums (Fig 7) all show the mounding from 1x turning speed out to vane pass frequency that often indicate suction cavitation. No single peaks are of sufficient amplitude to be alarming. The data needs to be trended.
