Mean Green Electric Generation

**Vibration Acceptance Report for
Cooling Water Pump #1**

*Submitted on
March 1st 2014*

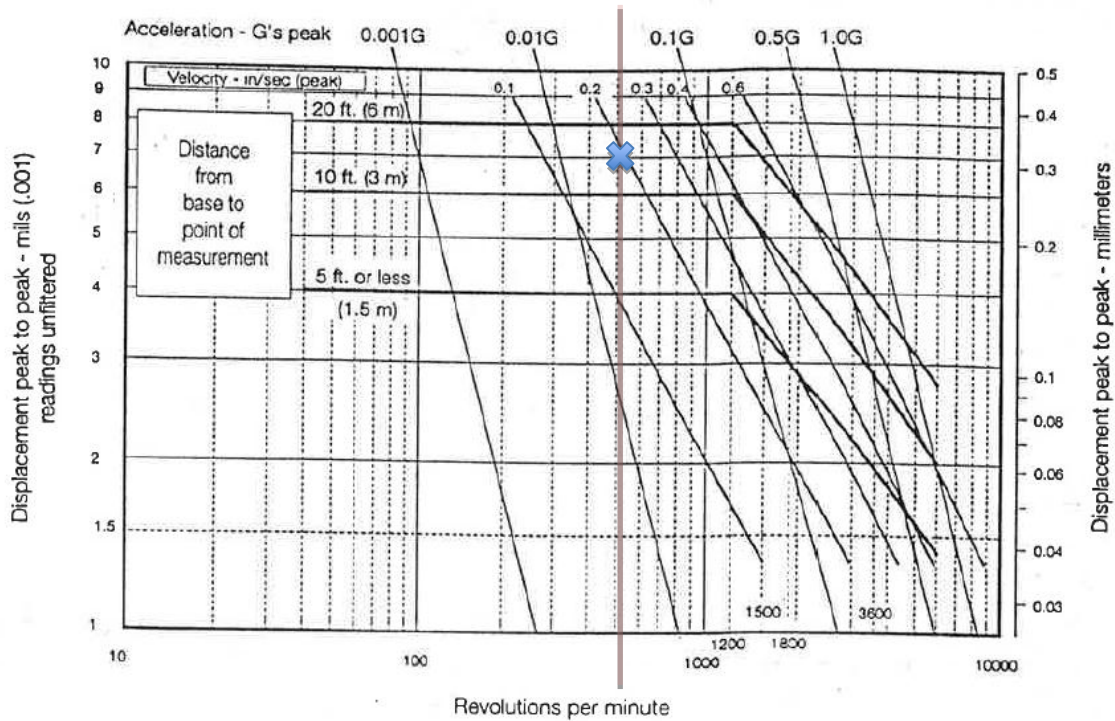
Figure 2.41 — Acceptable field vibration limits for vertical turbine pumps, mixed flow and axial flow pumps at best efficiency, at top motor bearing housing

The overall level recorded at the top bearing of the motor was below 0.02. The acceptable level is almost 10 times that level.

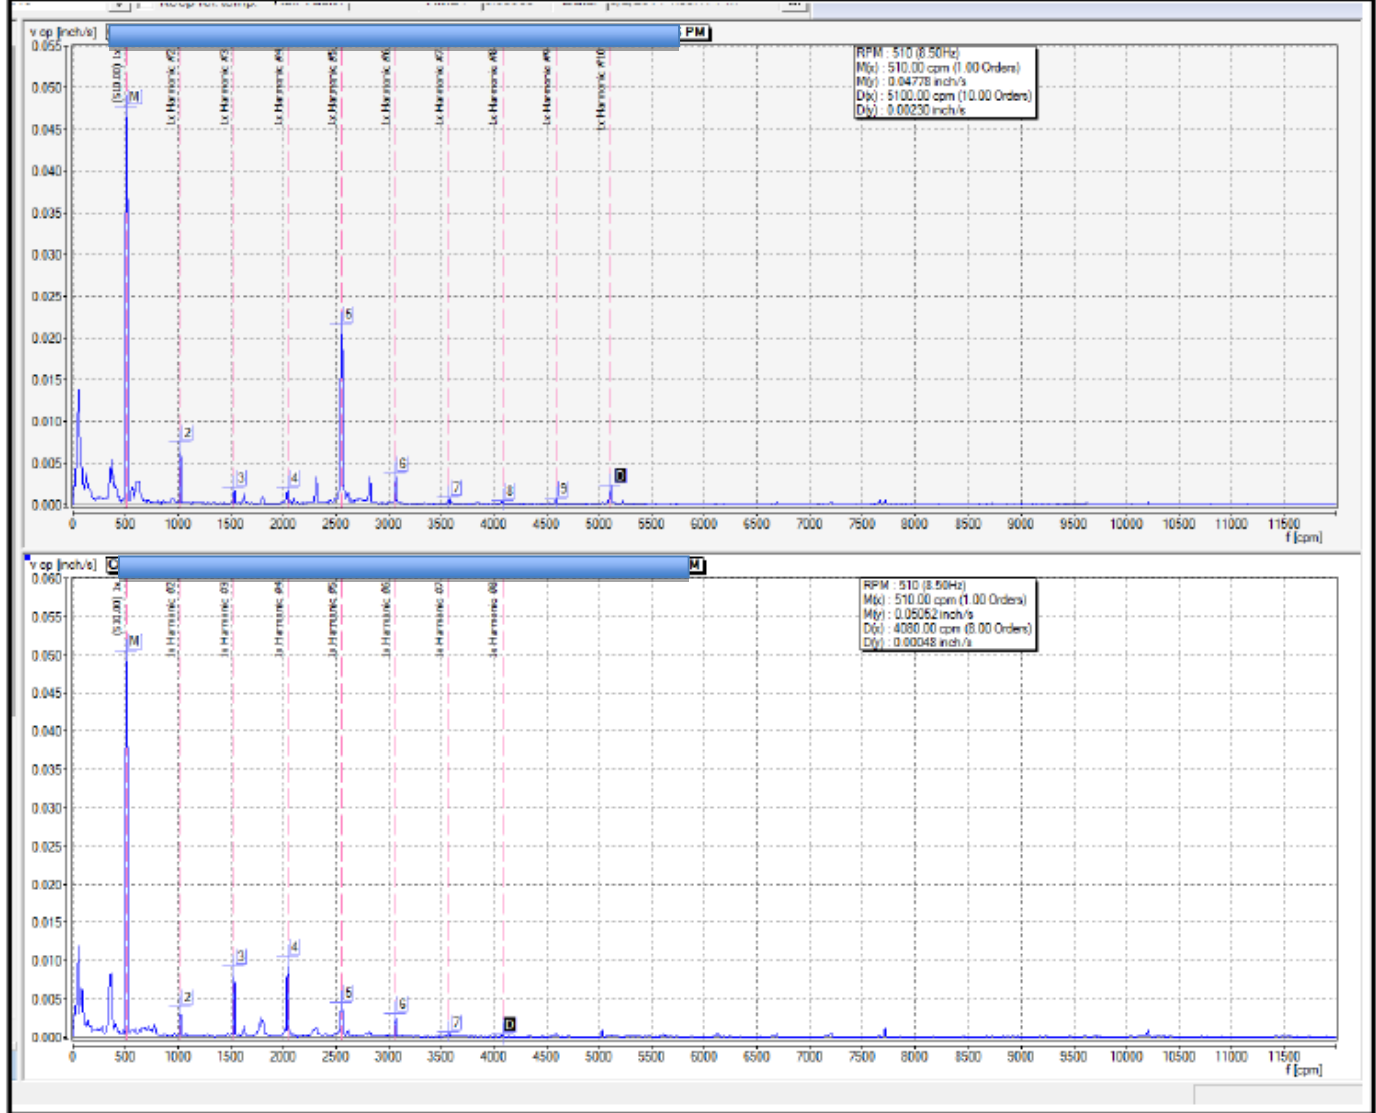
Looseness in the top bearing

Diagnosis		
Code	Brief Description	Status
DB	Several harmonics of turning speed most likely indicating slight mechanical looseness	Open

Description
The top bearing is showing some looseness. It does not appear to be dangerously severe at this time, but should be trended closely to alert to deteriorating condition of the Kingsbury upper thrust and guide bearing.

Name	Description
Cooling Water Pump #1 looseness in top brg	The Kingsbury upper thrust and guide bearing is showing aparent signs of looseness. The could be due to slightly excessive clearance or low viscosity of the lubricant. This should be trended closely to alert to deterioration of condition.

Correction Recommendation		
Code	Brief Description	Status
D	Trend	Open

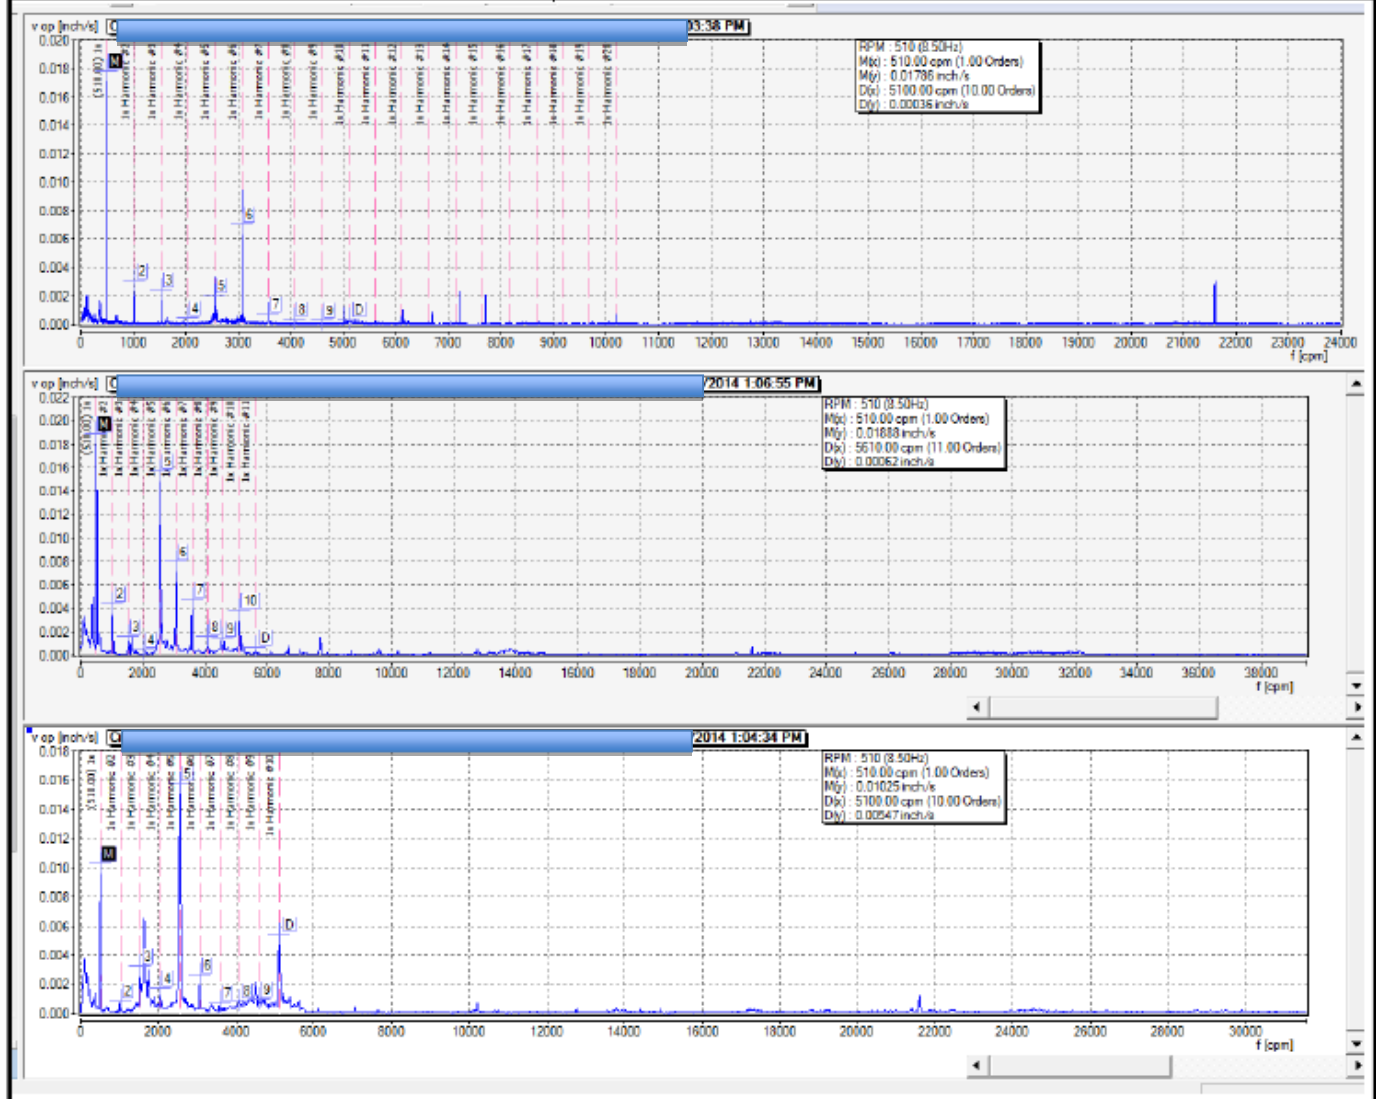
Diagnosis		
Code	Brief Description	Status
DB	Probable mechanical Looseness. Phase data should be collected in the future to help determine whether misalignment is contributing to this.	Open

Description
Looseness showing in bottom brg - low amplitude. Trend and at next round of data collection, collect phase data to determine if misalignment is contributing.

Name	Description
Pump #1 looseness showing in bottom brg	Many multiples of turning speed indicate probable looseness. Trend

Correction Recommendation		
Code	Brief Description	Status
CD	Phase data should be collected in the future to help determine whether misalignment is contributing to this.	Open
CC	Phase data should be collected in the future to help determine whether misalignment is contributing to this.	Open

1. Collect cross channel phase data on next routine gathering of data.
2. Check lube & lube system. (Mobil DTE Oil Heavy Medium or equivalent for Kingsbury?)
