One of the largest power plants in the United States experienced issues with two out of three recirculating pumps, which are critical for generating power. Despite regular monthly vibration route data collection, the pumps were running louder than normal, indicating a potential problem. To avoid a complete failure that would halt power generation, the plant implemented continuous monitoring using Sensotek's KAPPA X wireless vibration sensor from LUDECA on one of the recirculation pumps.

KAPPA X Case Study PREVENTING CATASTROPHIC FAILURE AND COSTLY REPLACEMENT AT A POWER PLANT

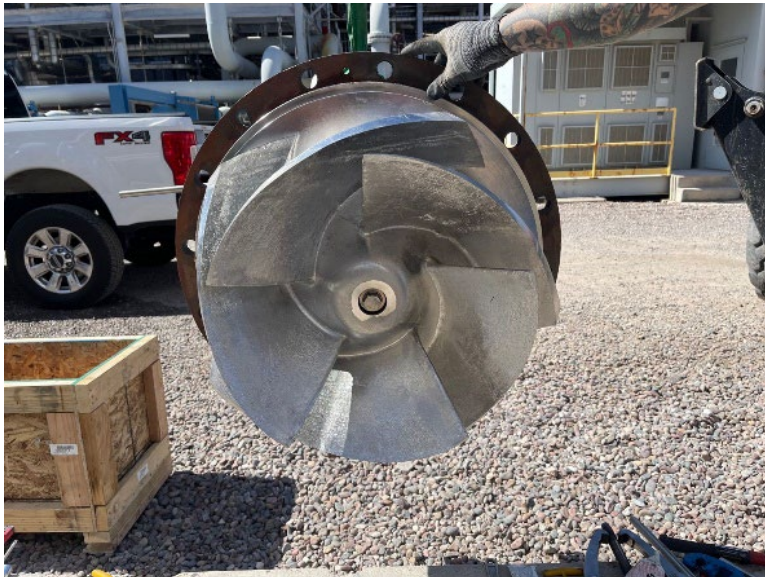
Power Frame and Pump Wet End Examination: During the overhaul, a careful examination of the pump power frame revealed significant damage. To rectify the issue, the pump power frame and mechanical seal were replaced. The Kappa X data played a critical role as the contractor was able to reuse the existing CD4 wet end of the pump which has a lead time of over 6+ months. If the Power frame would have completely failed the pump impeller would have made contact with the volute and possible stuffing box, rendering it unreparable and bringing the unit down for an undetermined amount of time until a new wet end could be retained. The data from the Kappa X also revealed that the discharge strainer baskets were completely plugged causing the pump to run at an extreme dead head destroying the thrust bearings in the pump power frame leading to extreme elevated vibration levels on three planes of the triaxial sensor (horizontal, vertical, and axial).

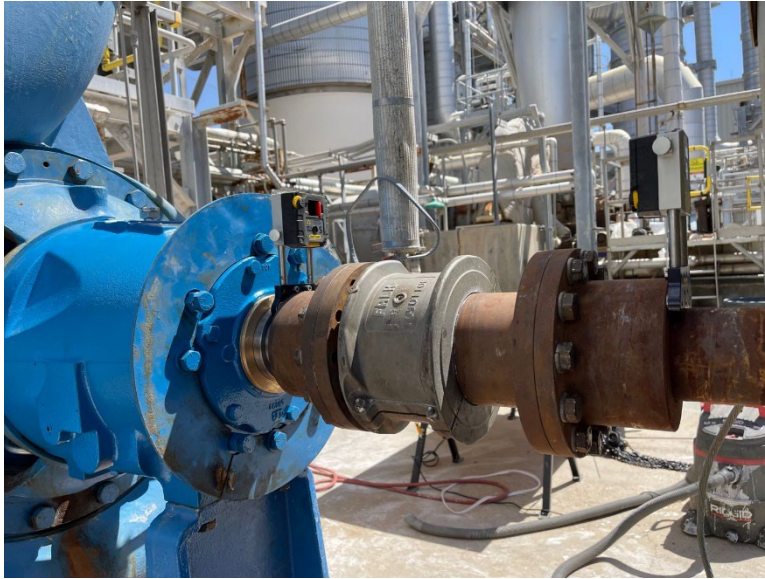
Laser Shaft Alignment and Pipe Strain Measurement: To ensure proper alignment, a precision alignment was performed using the Easy-Laser XT770 shaft alignment system. Additionally, pipe strain was measured and documented using the XT770 EasyTrend.
