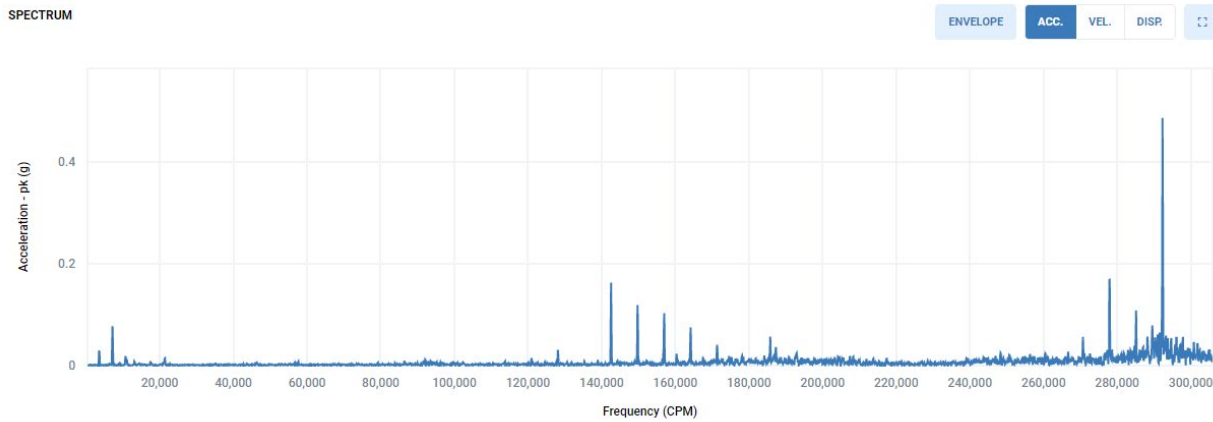
**Motor Drive End Bearing – Acceleration Spectrum (March 5, 2023)**

The benefits of KAPPA X wireless vibration monitoring system became evident soon after its installation. Just last month, the system detected defects in a DE motor bearing, triggering an alarm. Thanks to this early warning, the maintenance team swiftly replaced the motor, performed realignment, and had the blower operational within an hour. The system prevented extensive damage to the motor, coupling, and potentially another blower. The underlying cause of the motor bearing damage, severe misalignment and soft foot, was promptly addressed with the purchase of the Easy-Laser XT440 shaft alignment tool to correct the issue.

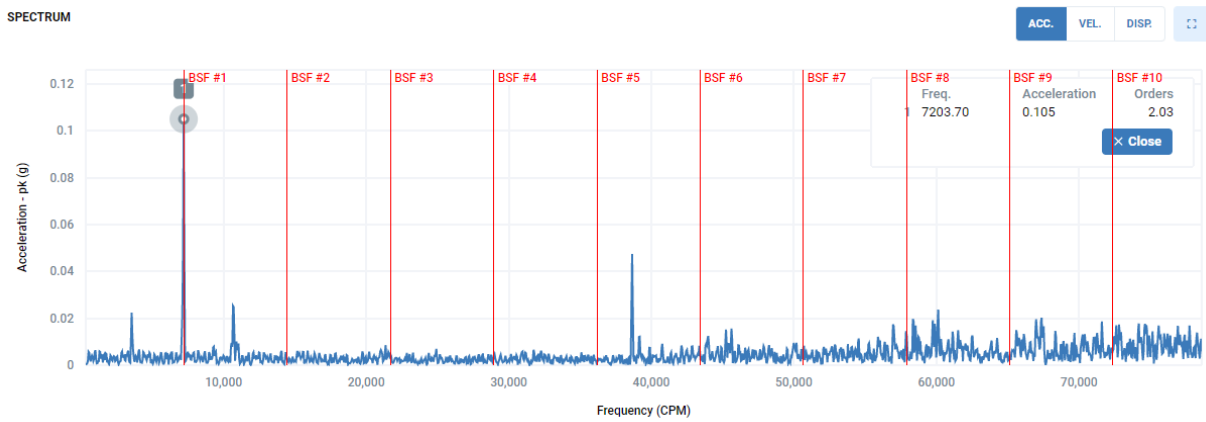
**Motor Drive End Bearing – Acceleration Spectrum (March 12, 2023)**

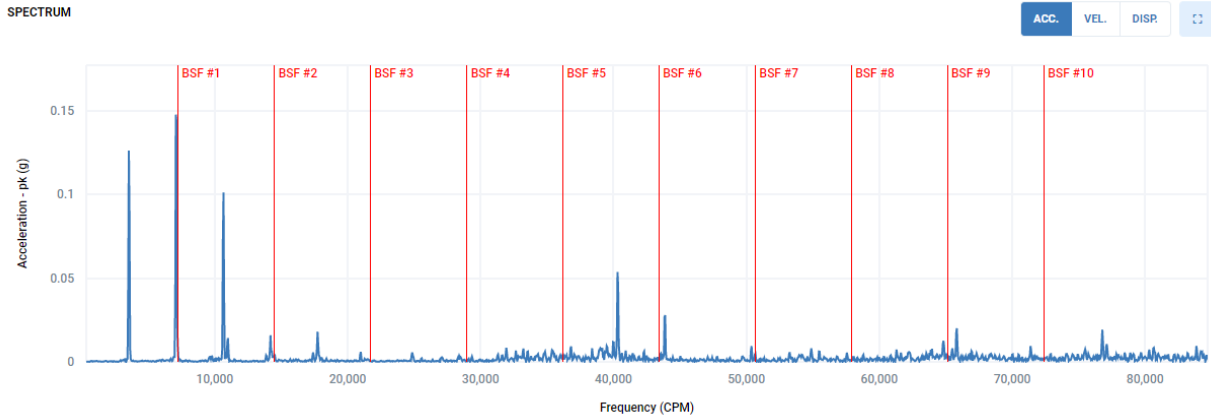
**Motor Drive End Bearing – Acceleration Spectrum (April 7, 2023)**
