# Where is that vibration coming from?

## » Production plant analyzes resonance anomaly; looks at condition monitoring program as a profit center

By Roger Earley, Lubrizol Corp., and Mike Fitch, Ludeca Inc.

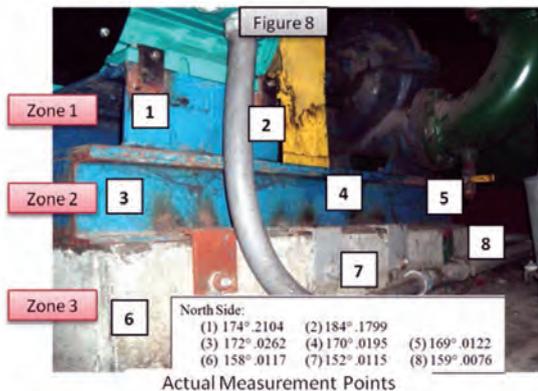
Figure 8 is a picture of the machine and its base with markers showing different points where data was taken, and a table showing the amplitude and phase data. There are three levels of base and foundation. Zone 1, where the readings labeled

“1” and “2” were taken, is the mount to which the motor is bolted. Zone 2, where the readings labeled “3,” “4” and “5” were taken, is the intermediate foundation (pump skid) to which the motor mount is welded and is itself mounted to the concrete foundation (level 3) where the readings labeled “6,” “7” and “8” were taken.

It can be seen in the table in Figure 8 that, as you travel upward from the foundation, each level is higher in amplitude, but they are all in phase. Notice also that the amplitude increases very little from Zone 3 to Zone 2, but there is nearly a 10x increase from Zone 2 to Zone 1. When comparing the bubble chart in Figure 7 to this data, one sees that the amplitude is about 2.5x higher on the motor than on the mount (Zone 1 in Figure 8), and virtually in phase. Now we get the idea of this motor rocking violently from side to side, from the interface between Zone 1 and 2 and up. Figure 9 illustrates the movement of this motor and its mount. It is shown in the maximum negative amplitude on the left, at rest or at zero in the center and the maximum positive amplitude on the right. This all represents one cycle of vibration at the turning
