### SonaVu™ Ultrasonic Acoustic Imaging Camera for Compressed Air Leak Management

### SonaVu™ Ultrasonic Acoustic Imaging Camera for Electrical Asset Reliability

### SonaVu™ Ultrasonic Acoustic Imaging Camera for Fugitive Emission Inspection

### SonaVu™ Ultrasonic Acoustic Imaging Camera for Dry Pipe Sprinkler Systems

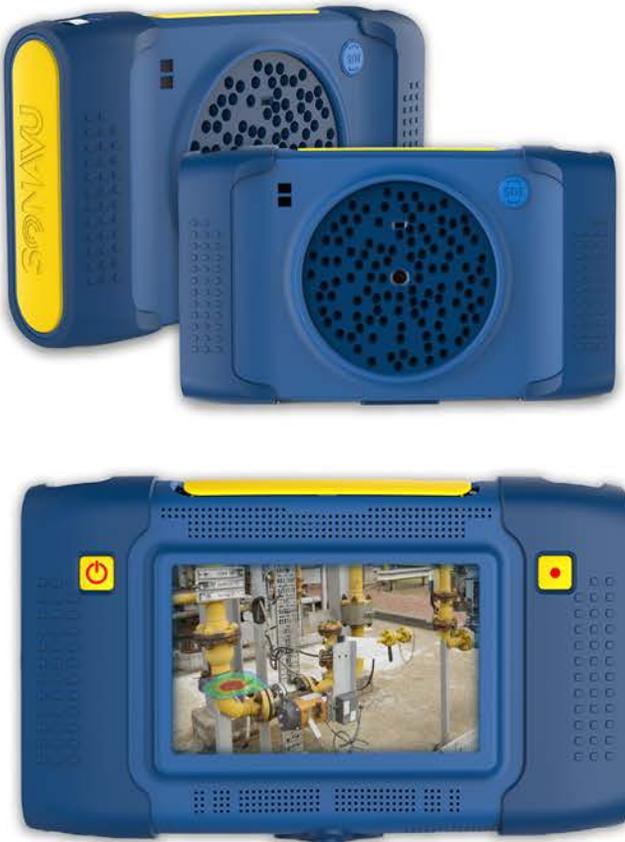
SonaVu™ (powered by SDT) is a multi-frequency acoustic imaging camera that blends visual and auditory senses to bring compressed air leaks into focus.

SonaVu™ is a multi-frequency acoustic camera that takes airborne ultrasound inspection to a new level. Equipped with 112 highly sensitive sonic sensors and a precision optical camera, SonaVu™ brings the power of super-human hearing to focus on its vibrant, color touch screen. It unlocks limitless applications for asset reliability, energy conservation, and safety including compressed air leak management, electrical asset reliability, tightness control of large volumes, and much more.

A simple leak detection procedure consists of picking up the SonaVu™ and powering it on. Connect the high-quality noise attenuating headphones so you can hear what SonaVu™ hears. Then simply point the acoustic sensor array towards any compressed air lines. Listen for the characteristic hissing of the air leaks in the headphones and watch the color display light up with the precise location of the leak.

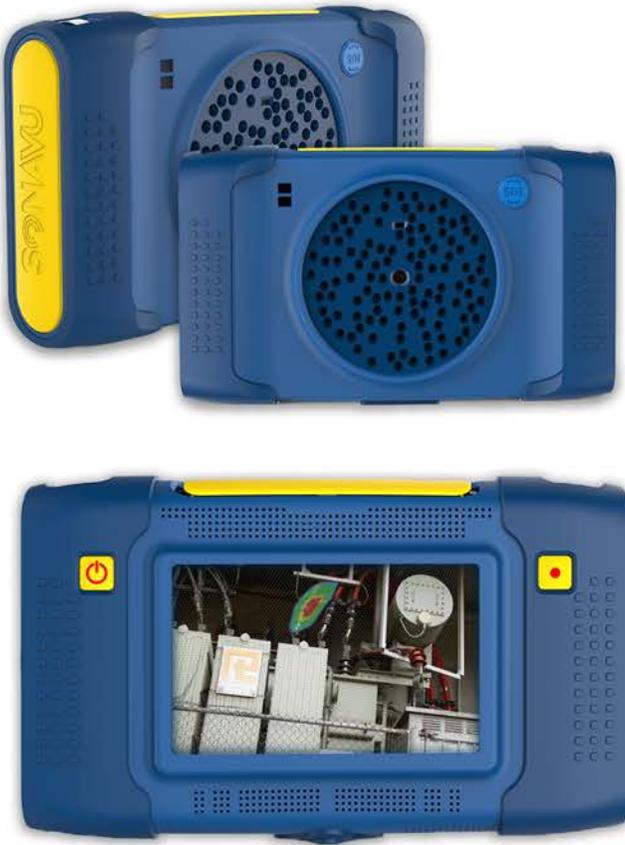
Sources of ultrasound created by the presence of partial discharge are superimposed on the image allowing inspectors to intuitively pinpoint their location.

The procedure for scanning is straightforward. Connect the noise attenuating headphones to the SonaVu™ and position the sensors towards potential sources. The ultrasound produced by partial discharge excites the sensors while their location is revealed on the display. Tap the icon to capture either a video or still image to place it into your inspection report. It's that easy!

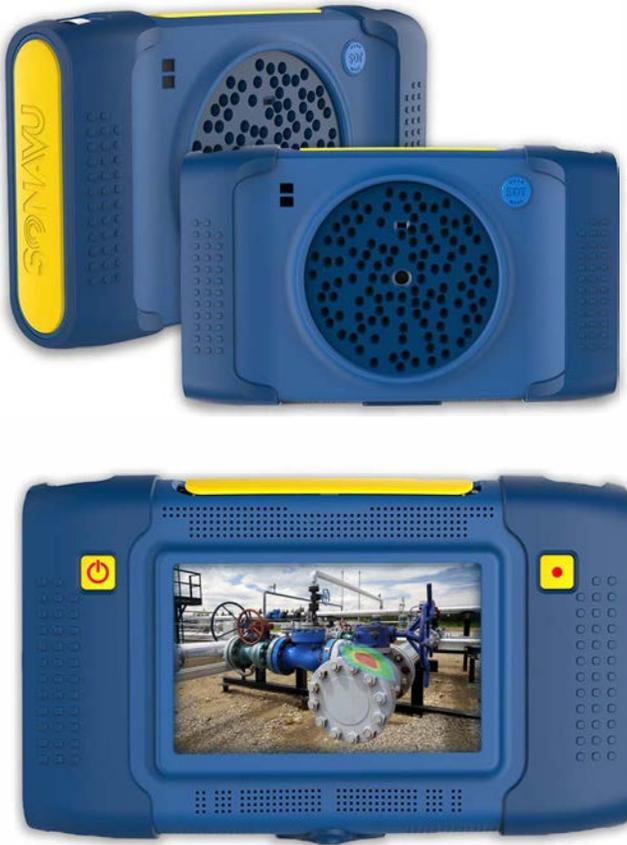
SonaVu™ is a multi-frequency acoustic imaging camera that blends visual and auditory senses to bring fugitive emissions, natural gas, and oil leaks into focus.

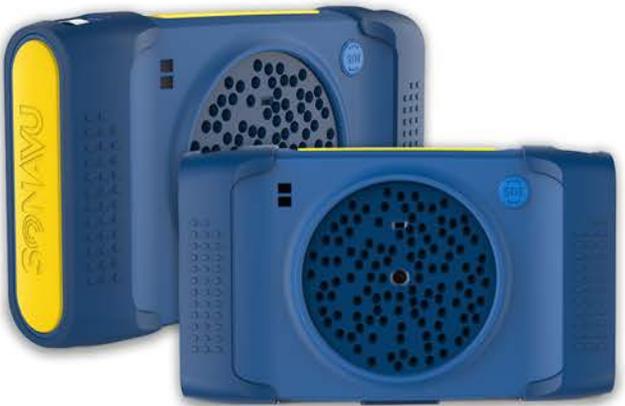
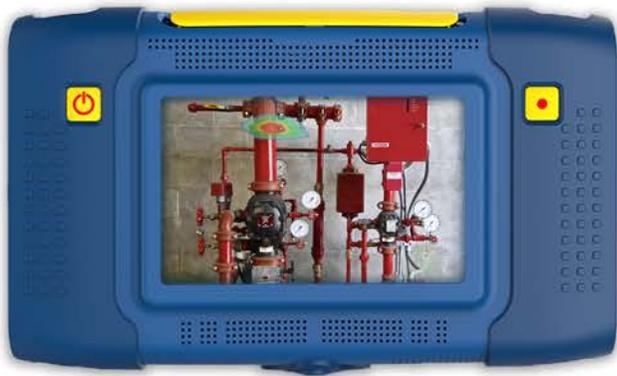
SonaVu™ is the perfect companion for dry pipe sprinkler system inspections and fire safety service providers should consider offering this leak detection to their clients.
